| Make: | Hyundai | Model: | Ix35 |
| Body Style: | SUV | Year: | 2014 |

Body Inspection Comments

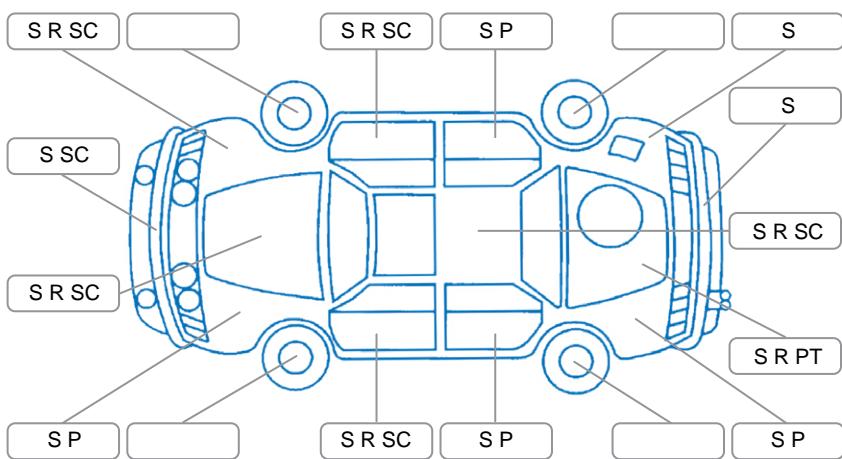
S = Scratch R = Rust C = Crack * = Decals W = Significant scuffs
 D = Dent PT = Paint defect P = Pin dent SC = Stone Chips

Note: some defects and blemishes may not be displayed in the diagram

Headlights Faded
 Fray in Left Front Seatbelt
 Moisture in Left Mirror Indicator
