| Make: | Peugeot | Model: | 307 |
| Body Style: | Sports Car | Year: | 2007 |

This report is a guide only. Consideration is made for age and mileage. Parts have not been dismantled or diagnostic testing undertaken. The vehicle has been driven up to 50km/h from cold. The Vendor recommends a full mechanical inspection prior to purchase and this can be arranged for an additional charge.

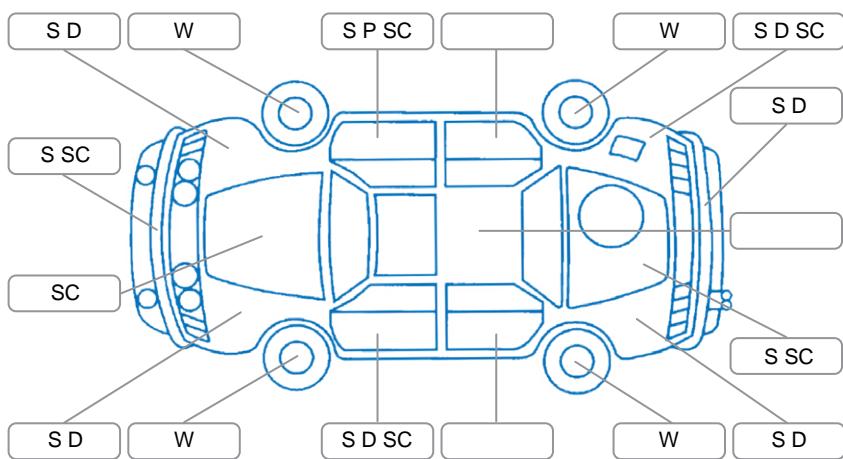
Note: some defects and blemishes may not be displayed in the diagram

Right rear tail light lens missing, Windscreen surround rubber perishing, Stop light display on dash board, convertible window switch doesn't work
