| Make: | Ford | Model: | Ranger |
| Body Style: | Utility | Year: | 2008 |

Body Inspection Comments

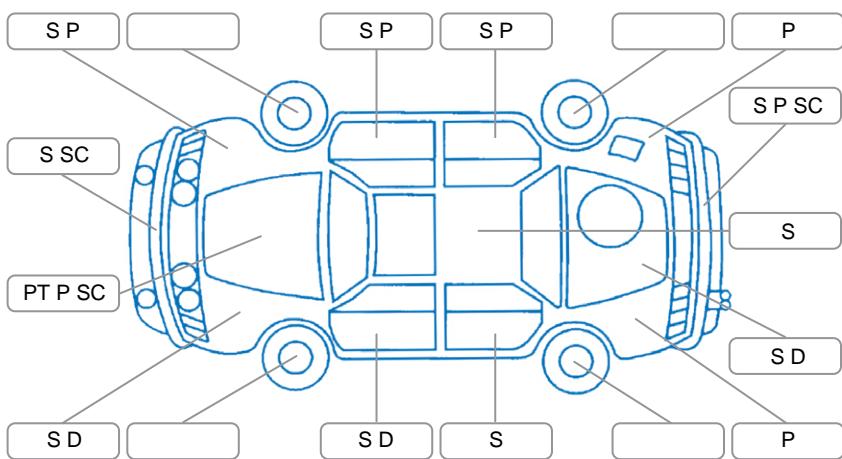
Note: some defects and blemishes may not be displayed in the diagram

Both tail light covers cracked.
 Battery not clamped down missing clamp bolts.
