Report ID:	27,886,766	Version:	2
Created:	31 Dec 2025

Make:	Mazda	Model:	Mazda3
Body Style:	Sedan	Year:	2006
Rego No.:	DGK109	Rego Expiry:	06 Aug 2026
WoF Expiry:	16 Jan 2026	Odometer:	284,638 Kms
Good No.:	27886766	VIN:	JM0BK10F100188081
Next Service:	284400	Service History:	No

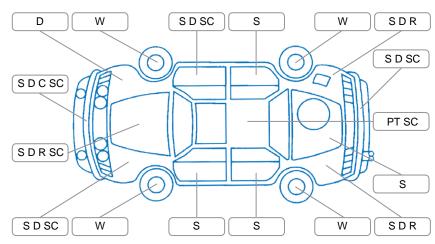
ney				
S = Scratch	R = Rust	C = Crack	* = Decals	W = Significant scuffs
D = Dent	PT = Paint defect	P = Pin dent	SC = Stone Chips

Note: some defects and blemishes may not be displayed in the diagram

Left wing mirror cover missing

Left tail light damaged

Minor stone chips on windscreen

Right tyre wall damaged
