| • | Report ID: 27,887,545 | | Version: | 1 |

| Make: | Toyota | Model: | Aurion |
| Body Style: | Sedan | Year: | 2011 |

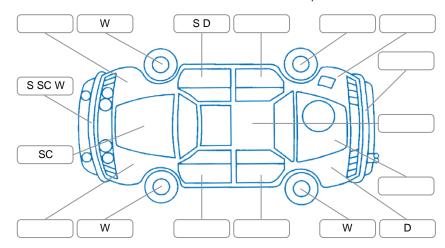
W = Significant scuffs S = ScratchR = RustC = Crack* = DecalsD = DentPT = Paint defect P = Pin dentSC = Stone Chips

Note: some defects and blemishes may not be displayed in the diagram $\,$
