Report ID:	27,890,487	Version:	1
Created:	04 Jan 2026

Make:	Suzuki	Model:	Escudo
Body Style:	SUV	Year:	2002
Rego No.:	EZW532	Rego Expiry:	01 Jul 2026
WoF Expiry:	09 Jan 2026	Odometer:	257,477 Kms
Good No.:	27890487	VIN:	7A8GK4M0709103390
Next Service:	258,000 Kms	Service History:	No

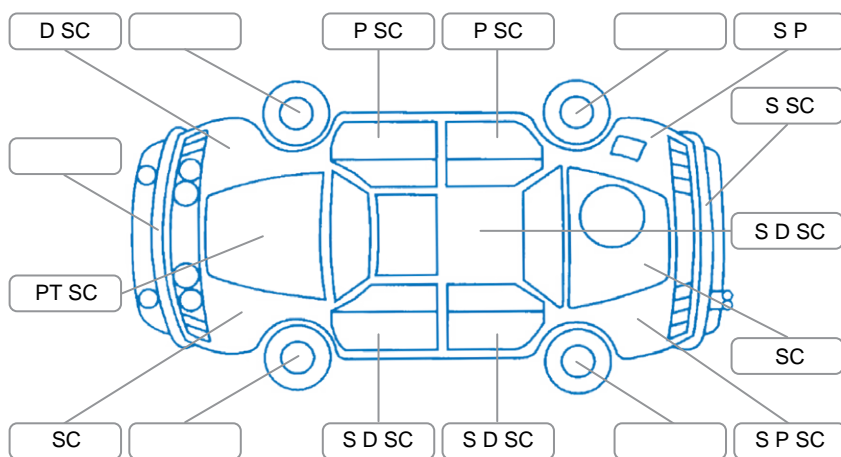
Note: some defects and blemishes may not be displayed in the diagram

Paint defect on RH cant rail and side mirror mounts. LH cant rail dented.  
FL door waste moulding damaged, RL door window frame damaged.  
FR door window monsoon missing.  
Missing tyre iron. Lock nut key in glovebox.
