| Make: | Ford | Model: | Escape |
| Body Style: | SUV | Year: | 2002 |
| Rego No.: | JZY112 | Rego Expiry: | 01 Apr 2026 |

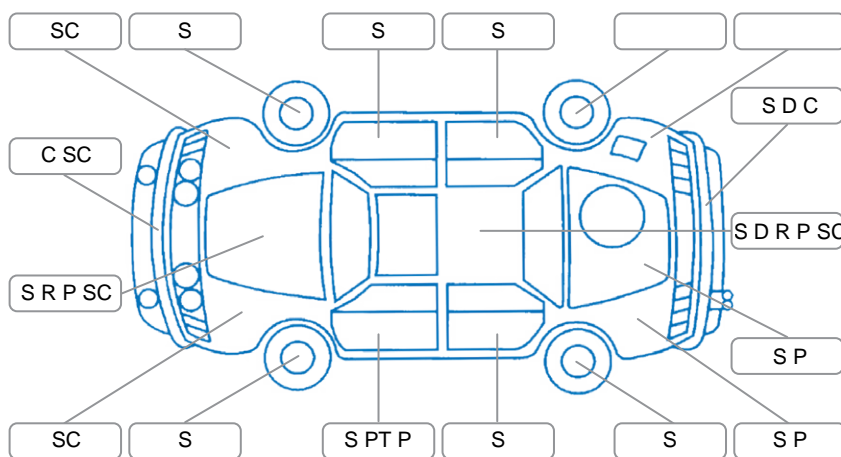
Note: some defects and blemishes may not be displayed in the diagram

Crack in middle bottom edge of windscreen. Small stone crack in left side of windscreen. Left side of grille is broken. Left edge broken off stone guard on front of bonnet.
