| Make: | Subaru | Model: | Impreza |
| Body Style: | Wagon | Year: | 2011 |

Body Inspection Comments

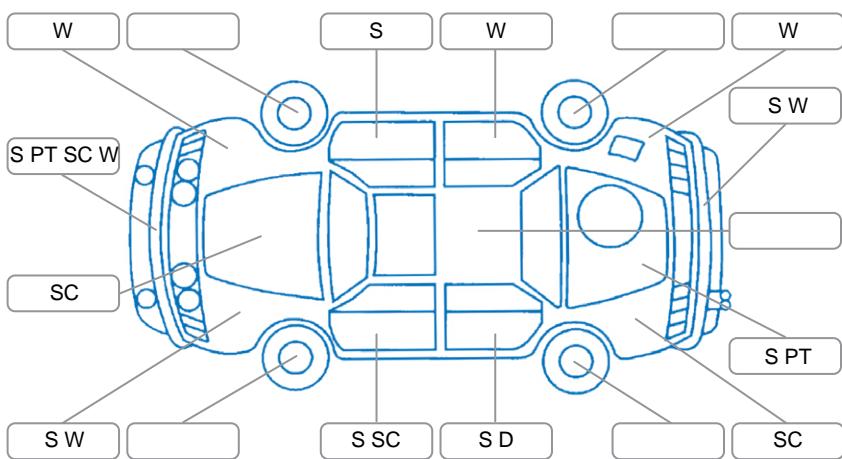
S = Scratch R = Rust C = Crack * = Decals W = Significant scuffs
 D = Dent PT = Paint defect P = Pin dent SC = Stone Chips

Note: some defects and blemishes may not be displayed in the diagram
