Report ID:	27,918,047	Version:	1
Created:	20 Jan 2026

Make:	LDV	Model:	T60
Body Style:	Utility	Year:	2019
Rego No.:	PQT479	Rego Expiry:	05 Nov 2025
WoF Expiry:	13 Nov 2026	Odometer:	125,270 Kms
Good No.:	27918047	VIN:	LSFAM11A3JA095969
Next Service:	134235 kms	Service History:	No

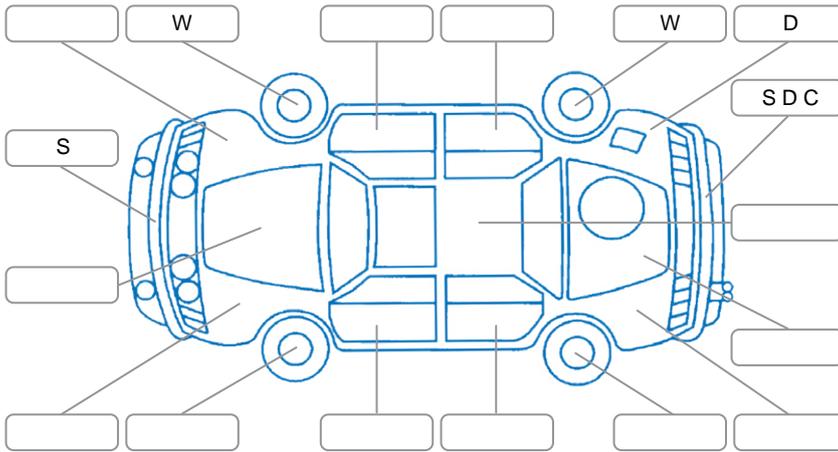
Rear bumper damage, L rear interior door panel missing, L wing mirror cover and indicator broken, r front fog light damage, underbody rust, engine oil leak, underbody steel cover unsecured,
