| Report ID: | 27,920,583 | Version: | 1 |

| Make: | Ford | Model: | Courier |
| Body Style: | Utility | Year: | 2004 |

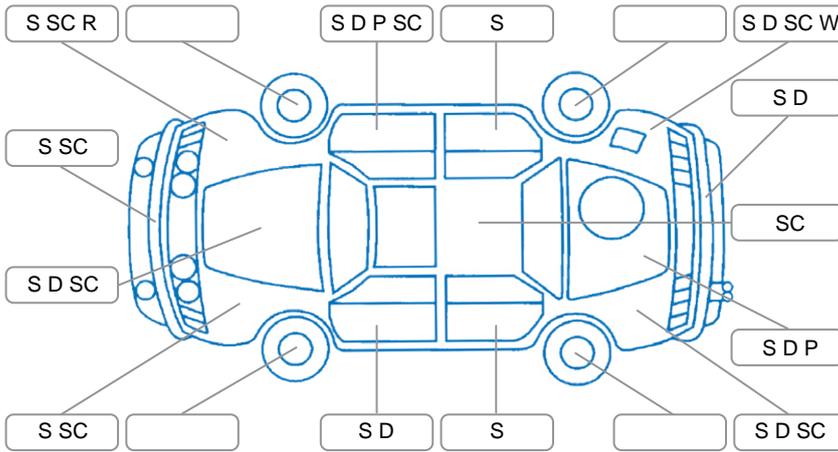
Note: some defects and blemishes may not be displayed in the diagram

No keys for locks on rear canopy door. Some of the tools for using vehicle jack are missing. Paint peeling off canopy roof. Small stone crack in right side of windscreen.
