| Report ID: | 27,946,684 | Version: | 2 |

| Make: | Mazda | Model: | Bt-50 |
| Body Style: | Utility | Year: | 2018 |

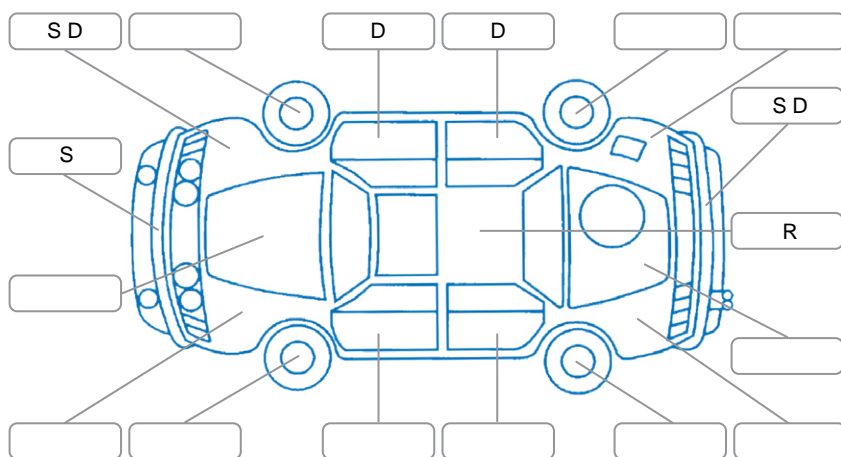
Note: some defects and blemishes may not be displayed in the diagram

Rear bumper unsecured parts, high stop light broken, r front park light not working, underbody mud and stone, start rust underneath.canopy key mismatch,
