| Make: | Ford | Model: | Fiesta |
| Body Style: | Hatchback | Year: | 2009 |

Body Inspection Comments

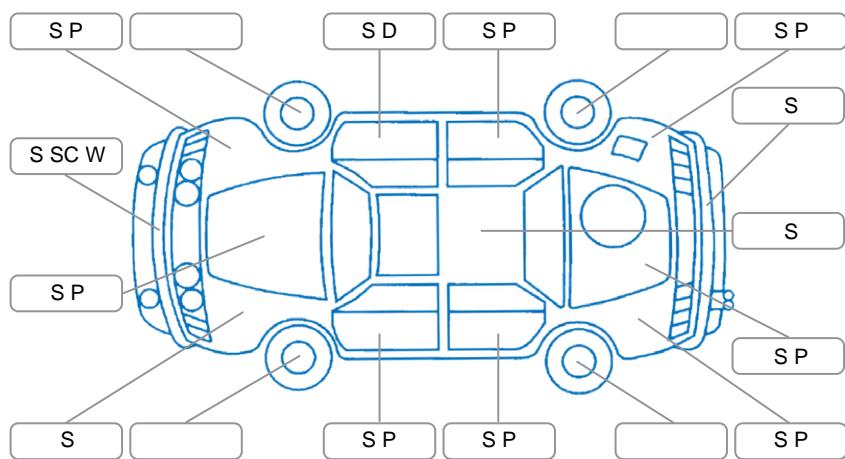
Note: some defects and blemishes may not be displayed in the diagram

Spare wheel not secured. Right taillight corner piece missing. Right wingmirror repeater condensation.
