Report ID:	27,961,577	Version:	1
Created:	10 Feb 2026

Make:	Mazda	Model:	Bt-50
Body Style:	Utility	Year:	2015
Rego No.:	JDD739	Rego Expiry:	21 Jun 2025
WoF Expiry:	15 Sep 2026	Odometer:	156,760 Kms
Good No.:	27961577	VIN:	MMOUP0YF100225225
Next Service:	143,000 kms	Service History:	No

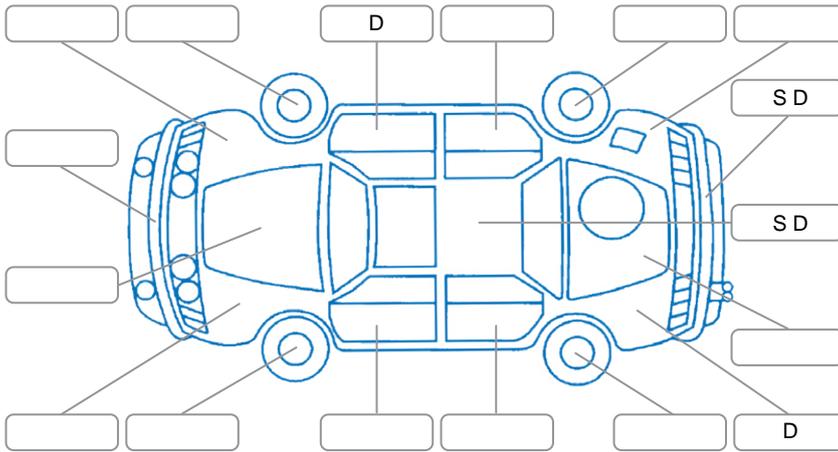
R rear door panel sagging missing, r inner tail light fault damage, L rear fog light glass cracked, both front seat plastic cover unsecured, windscreen stone chip in the edge, engine oil leak, underbody rust, R front ball joint play,
