| Make: | Dodge | Model: | Journey |
| Body Style: | SUV | Year: | 2012 |

Body Inspection Comments

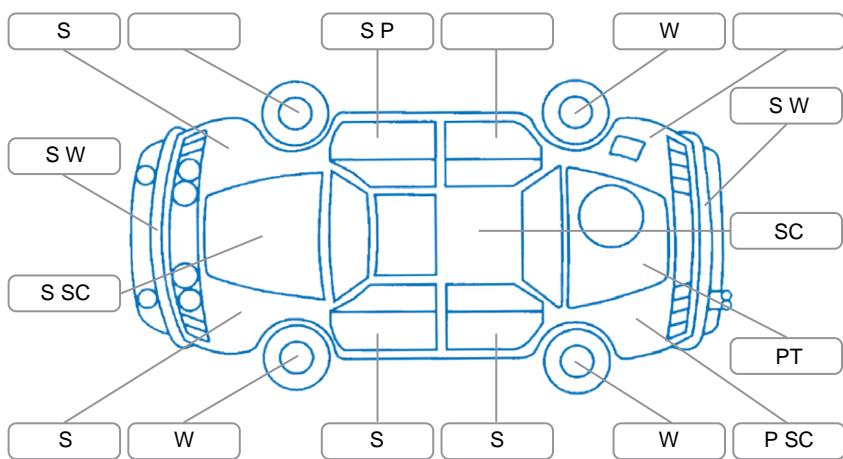
S = Scratch R = Rust C = Crack * = Decals W = Significant scuffs
D = Dent PT = Paint defect P = Pin dent SC = Stone Chips

Note: some defects and blemishes may not be displayed in the diagram

Stone chip in windscreens
