Report ID:	27,978,037	Version:	1
Created:	13 Feb 2026

Make:	Volkswagen	Model:	Golf
Body Style:	Hatchback	Year:	2013
Rego No.:	MGR307	Rego Expiry:	22 Dec 2026
WoF Expiry:	08 Oct 2026	Odometer:	177,633 Kms
Good No.:	27978037	VIN:	WVWZZZAUZEW098615
Next Service:	183,000kms	Service History:	No

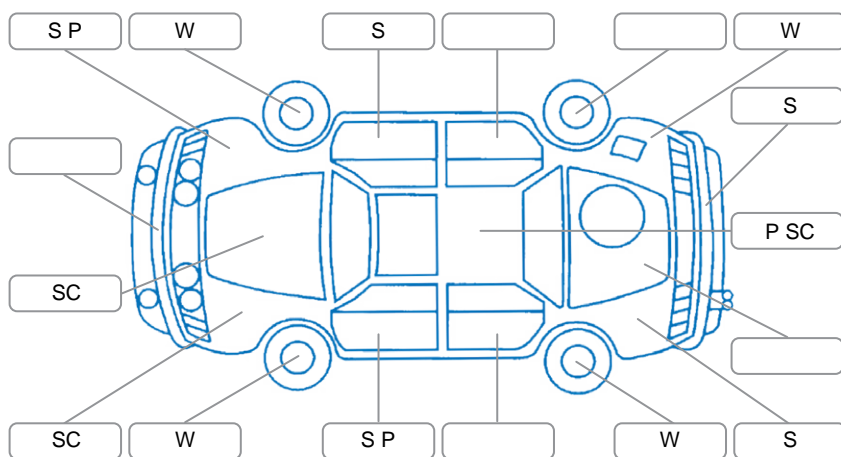
S = Scratch R = Rust C = Crack * = Decals W = Significant scuffs
D = Dent PT = Paint defect P = Pin dent SC = Stone Chips

Note: some defects and blemishes may not be displayed in the diagram

Bonnet gas strut is not operating.
