| Report ID: | 27,987,148 | Version: | 1 |

| Make: | Holden | Model: | Trax |
| Body Style: | SUV | Year: | 2014 |

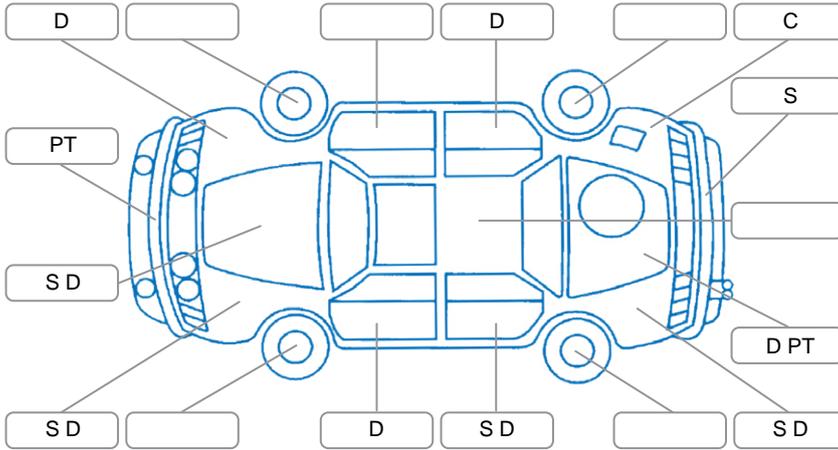
Key
 S = Scratch R = Rust C = Crack * = Decals W = Significant scuffs
 D = Dent PT = Paint defect P = Pin dent SC = Stone Chips

Note: some defects and blemishes may not be displayed in the diagram

Rear bumper tow hook cover missing, parcel tray missing, passenger seat plastic cover torn, engine oil leak, L front wheel play,
