Report ID:	27,987,327	Version:	3
Created:	26 Feb 2026

Make:	BMW	Model:	318I CON
Body Style:	Convertible	Year:	1991
Rego No.:	GMF547	Rego Expiry:	
WoF Expiry:	29 Jul 2022	Odometer:	220,122 Kms
Good No.:	27987327	VIN:	WBABA52090EJ35574
Next Service:	226000 kms	Service History:	No

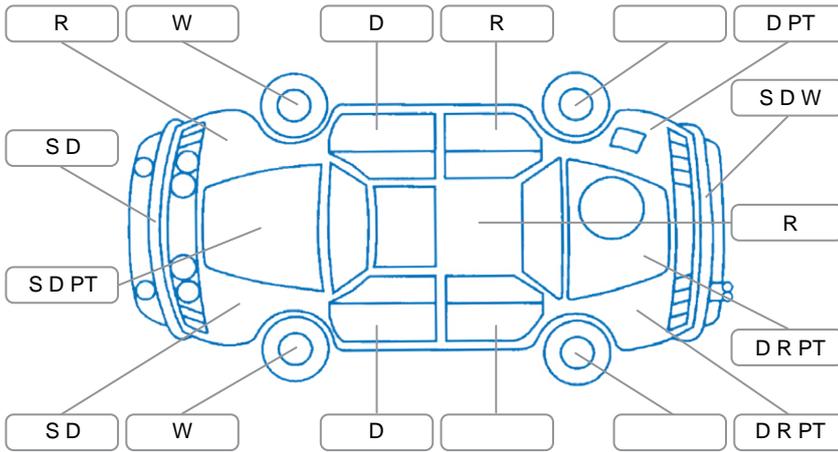
Key
 S = Scratch R = Rust C = Crack * = Decals W = Significant scuffs
 D = Dent PT = Paint defect P = Pin dent SC = Stone Chips

Note: some defects and blemishes may not be displayed in the diagram

Both front tail light damage and cracked, windscreen cracked, exterior body rust, engine oil leak, steering rock play, leak and boot split, flat battery, rear differential leak, shock lower spring noise when driving underneath, all brake rotor rust,
