| Report ID: | 27,988,748 | Version: | 5 |

| Make: | Holden | Model: | Captiva 5 |
| Body Style: | SUV | Year: | 2015 |

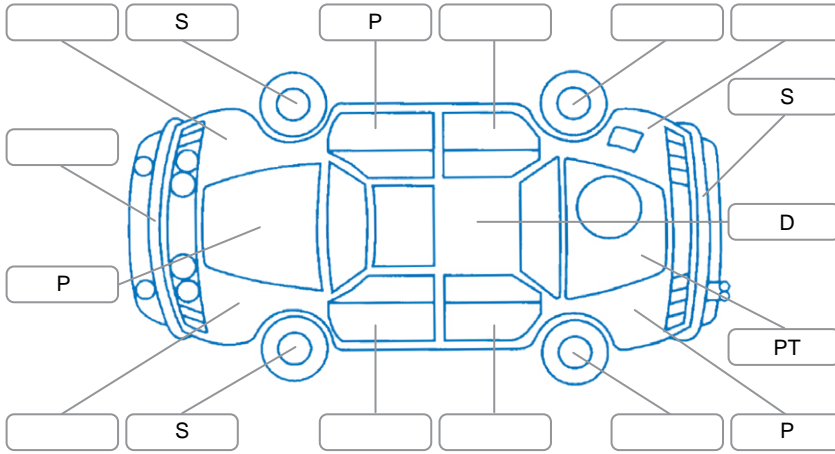
S = Scratch R = Rust C = Crack * = Decals W = Significant scuffs
 D = Dent PT = Paint defect P = Pin dent SC = Stone Chips

Note: some defects and blemishes may not be displayed in the diagram
