Report ID:	28,011,834	Version:	1
Created:	26 Feb 2026

Make:	Toyota	Model:	Landcruiser Prado
Body Style:	Wagon	Year:	1991
Rego No.:	BPL328	Rego Expiry:	18 Jun 2025
WoF Expiry:	24 Aug 2026	Odometer:	296,011 Kms
Good No.:	28011834	VIN:	7A8H60H0799017007
Next Service:	Unreadable	Service History:	No

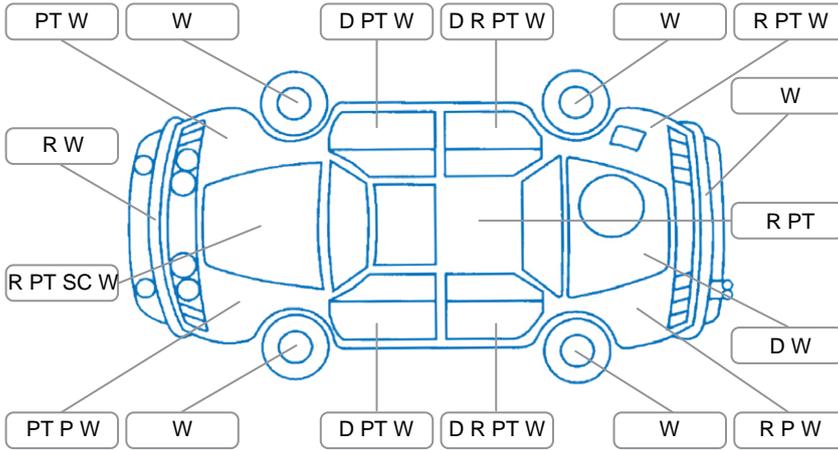
Note: some defects and blemishes may not be displayed in the diagram

Both A pillar pin dent & rust
 Bonnet is catching to firewall cover panel
