| Report ID: | 28,018,533 | Version: | 1 |

| Make: | Rover | Model: | Mini |
| Body Style: | Sedan | Year: | 1993 |

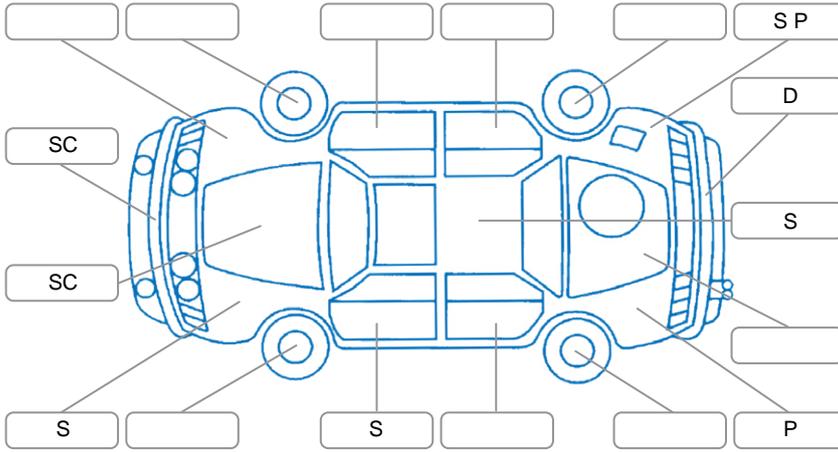
S = Scratch R = Rust C = Crack * = Decals W = Significant scuffs
 D = Dent PT = Paint defect P = Pin dent SC = Stone Chips

Note: some defects and blemishes may not be displayed in the diagram
