| Report ID: | 28,023,653 | Version: | 1 |

| Make: | Nissan | Model: | X-Trail |
| Body Style: | SUV | Year: | 2015 |

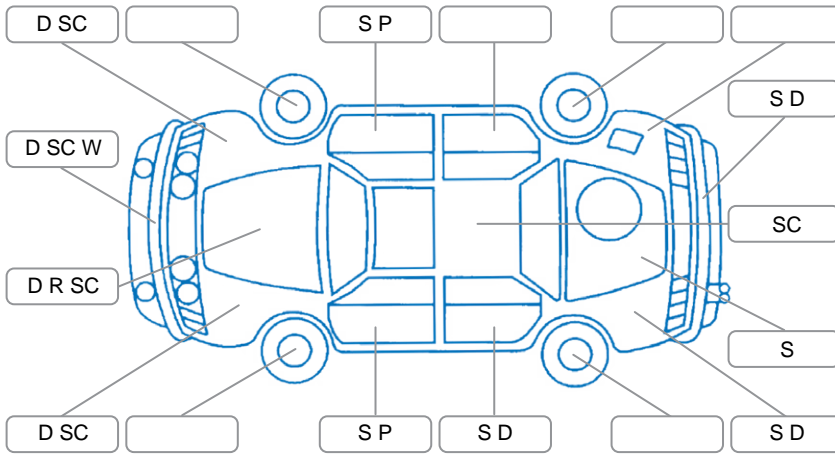
Note: some defects and blemishes may not be displayed in the diagram

4 New tyres. Minor spider rusts are developing on roof. Front bumper tow point cover is missing.
