Report ID:	28,033,429	Version:	1
Created:	10 Mar 2026

Make:	Toyota	Model:	Hilux
Body Style:	Utility	Year:	2010
Rego No.:	FPT112	Rego Expiry:	27 Oct 2026
WoF Expiry:	05 Sep 2026	Odometer:	274,423 Kms
Good No.:	28033429	VIN:	MR0FZ29G101602235
Next Service:	283,000	Service History:	No

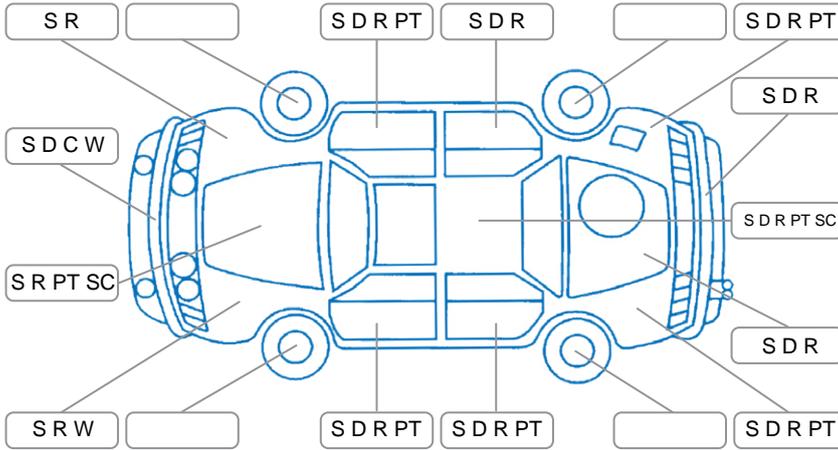
Note: some defects and blemishes may not be displayed in the diagram

No jack or tools. Holes in left inner guard. Upper grille popped out. Left step dented, right step missing. Headlights yellow. Stone chips in windscreen. Paint worn in door sills. Dents in roof & back of cab. Taillights cracked. Tailgate stuck shut.
