| Report ID: | 28,054,453 | Version: | 2 |

| Make: | Holden | Model: | Colorado |
| Body Style: | Utility | Year: | 2012 |

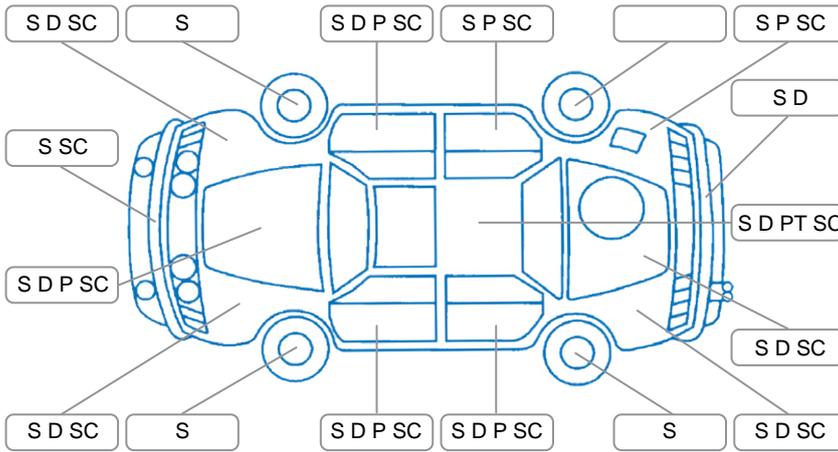
Paint defect on RH side mirror and RH cant rail. Both cant rails dented.
 Rear bumper step plate moulding cracked. Rear bumper pushed in.
 Canopy window tints in poor condition. Stonechips in windscreen.
 LH taillight cracked, RH taillight chipped.
