Report ID:	28,054,741	Version:	1
Created:	18 Mar 2026

Make:	Honda	Model:	Insight
Body Style:	Hatchback	Year:	2010
Rego No.:	MFW284	Rego Expiry:	09 Jun 2026
WoF Expiry:	31 Oct 2026	Odometer:	224,265 Kms
Good No.:	28054741	VIN:	7AT08G9MX19205435
Next Service:	can't read	Service History:	No

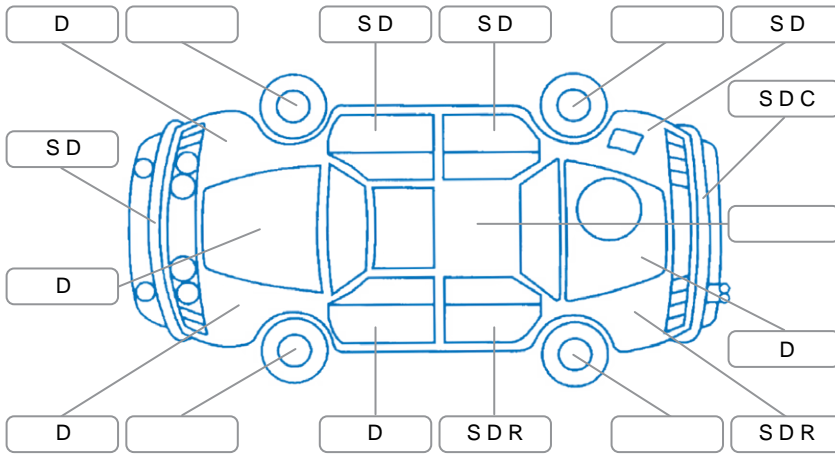
Note: some defects and blemishes may not be displayed in the diagram

Driver body seal torn, L rear window not working, steering wheel torn, carpet torn, L wing mirror adjuster not folding, r rear body seal torn, passenger seat torn, parcel tray missing, number plate not working.
