Report ID:	28,061,959	Version:	1
Created:	21 Mar 2026

Make:	Ford	Model:	Ranger
Body Style:	Utility	Year:	2009
Rego No.:	RQR397	Rego Expiry:	23 Aug 2026
WoF Expiry:	02 Dec 2026	Odometer:	410,406 Kms
Good No.:	28061959	VIN:	MNALSFE909W829528
Next Service:	410,842 Kms	Service History:	Yes

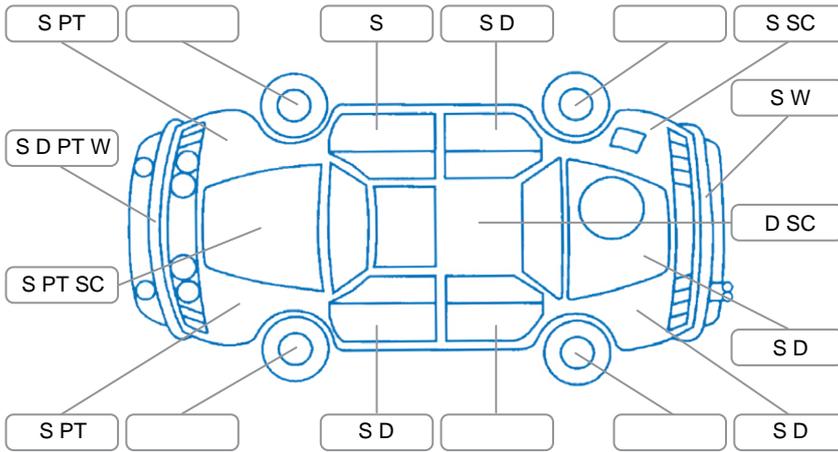
Note: some defects and blemishes may not be displayed in the diagram

- Rust in boot lid jamb
- Hole in front left guard flare
- Paint defect front door jambs
- Front right park light isn't working
