Report ID:	28,066,585	Version:	1
Created:	20 Mar 2026

Make:	Ford	Model:	Ranger
Body Style:	Utility	Year:	2013
Rego No.:	HDL913	Rego Expiry:	24 Nov 2026
WoF Expiry:	16 Jan 2027	Odometer:	223,198 Kms
Good No.:	28066585	VIN:	MNAUMFF50DW220081
Next Service:	230723 kms	Service History:	No

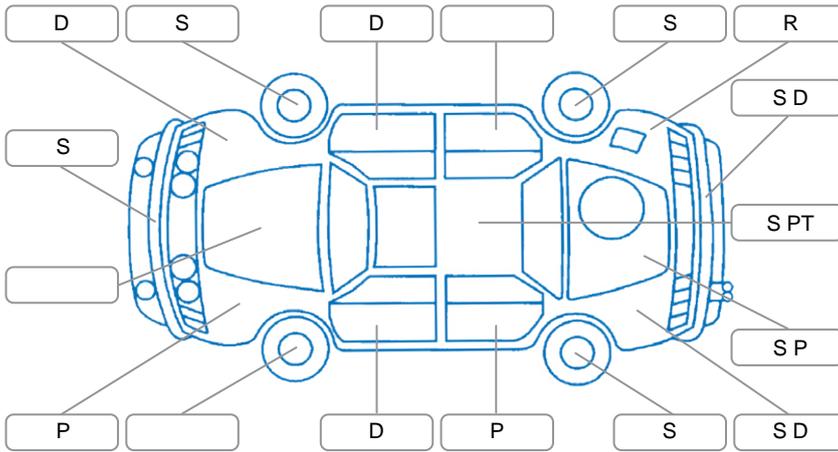
**Key**  
 S = Scratch    R = Rust    C = Crack    \* = Decals    W = Significant scuffs  
 D = Dent    PT = Paint defect    P = Pin dent    SC = Stone Chips

Note: some defects and blemishes may not be displayed in the diagram

Headliner marks. Steering control buttons missing. Steering wheel and gear knob worn. LF door seal damage. Front seat plastic bases loose/broken. Rear bumper pushed in.
