Report ID:	28,073,391	Version:	1
Created:	01 Apr 2026

Make:	Toyota	Model:	Corolla
Body Style:	Hatchback	Year:	2006
Rego No.:	DPT52	Rego Expiry:	28 Aug 2026
WoF Expiry:		Odometer:	257,233 Kms
Good No.:	28073391	VIN:	JTDKR22E900259105
Next Service:	267,800km's	Service History:	No

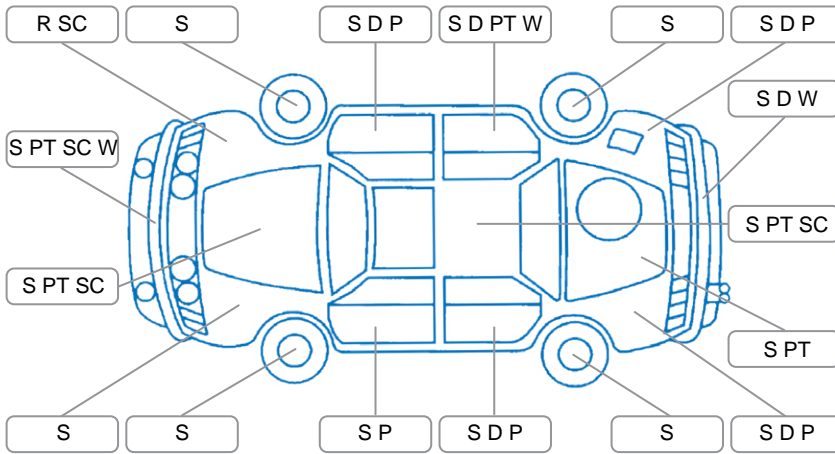
Note: some defects and blemishes may not be displayed in the diagram

Bonnet is not aligning correctly, cover hanging front grille panel & right side panel gap is large & not straight. Right front headlight top mounting brackets are broken. Paint clear coat peeling off bonnet. Plastic corner trim in left front bumper is missing. Left front bumper not fitting correctly
