Report ID:	28,076,190	Version:	1
Created:	25 Mar 2026

Make:	Toyota	Model:	Landcruiser
Body Style:	Wagon	Year:	1992
Rego No.:	XP8525	Rego Expiry:	31 May 2026
WoF Expiry:	13 May 2026	Odometer:	381,397 Kms
Good No.:	28076190	VIN:	7A8H60H0798022337
Next Service:	388,506	Service History:	No

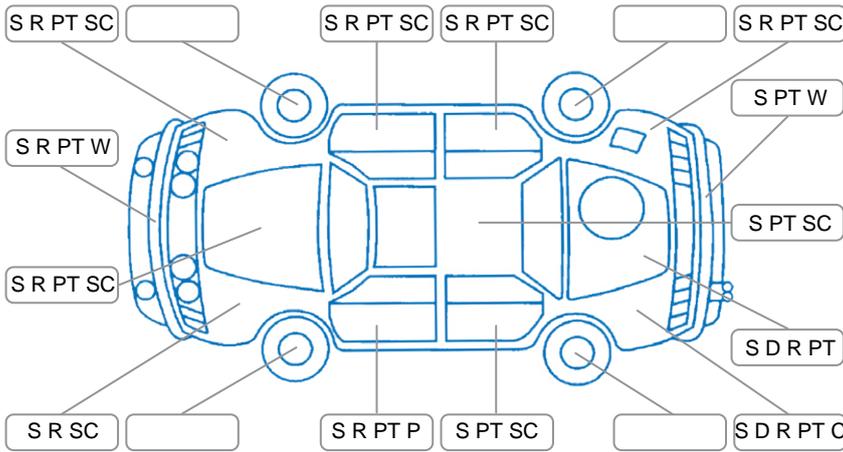
Note: some defects and blemishes may not be displayed in the diagram

Rust on inner lower edge of left front door. Left taillight cracked. Spare wheel not roadworthy
