Report ID:	28,087,531	Version:	3
Created:	07 Apr 2026

Make:	Toyota	Model:	Hiace
Body Style:	Minibus	Year:	2006
Rego No.:	HDZ906	Rego Expiry:	24 Apr 2026
WoF Expiry:	27 Mar 2027	Odometer:	270,079 Kms
Good No.:	28087531	VIN:	7AT0H60FX13005159
Next Service:	280, 083 Kms	Service History:	No

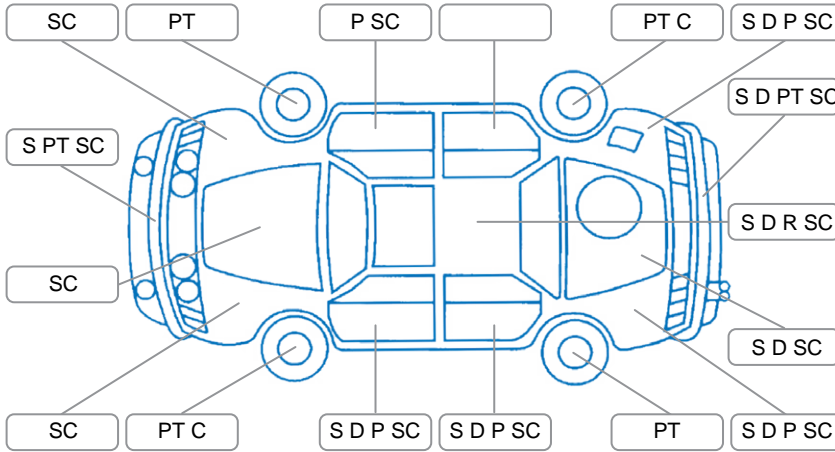
S = Scratch R = Rust C = Crack * = Decals W = Significant scuffs
 D = Dent PT = Paint defect P = Pin dent SC = Stone Chips

Note: some defects and blemishes may not be displayed in the diagram

Both front wheel arch/step plate panels worn. LH B pillar dented.
 Minor cracks and moisture in RH taillight. LH taillight cracked.
 LH cant rail dented/scraped. Rust on roof.
 Tailgate mirror missing. Missing tools. RH sill dented.
