| Report ID: | 28,088,585 | Version: | 1 |

| Make: | Mazda | Model: | Atenza |
| Body Style: | Wagon | Year: | 2012 |

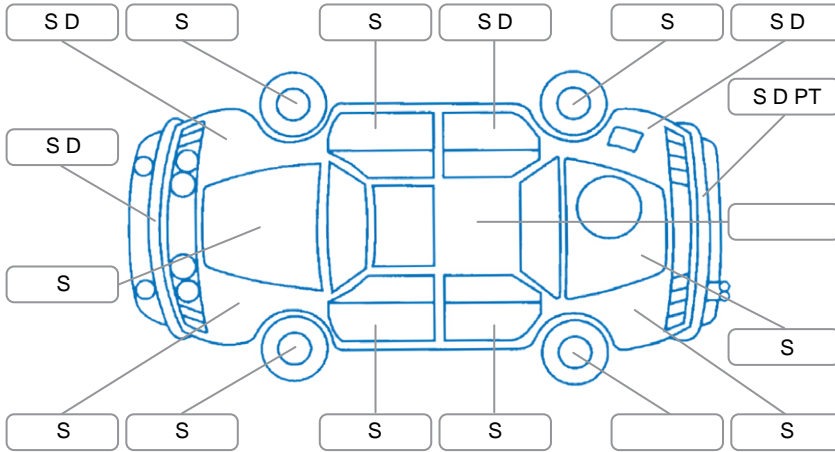
Note: some defects and blemishes may not be displayed in the diagram

Right wing mirror damage, front bumper unsecure needs to refit, rear right tyre sidewall damage and different ,
