Report ID:	28,113,814	Version:	1
Created:	15 Apr 2026

Make:	Mazda	Model:	Axela
Body Style:	Hatchback	Year:	2010
Rego No.:	LBZ300	Rego Expiry:	06 May 2026
WoF Expiry:	27 Apr 2027	Odometer:	215,344 Kms
Good No.:	28113814	VIN:	7AT0C13JX15114506
Next Service:	225,341km's	Service History:	No

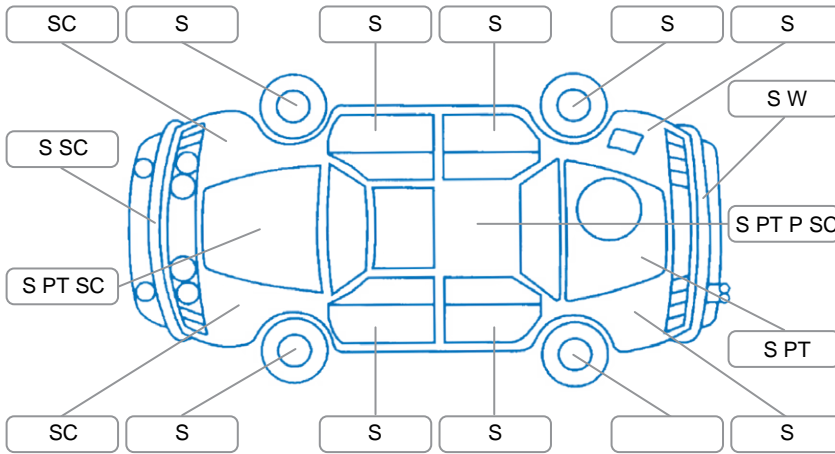
Note: some defects and blemishes may not be displayed in the diagram

Plastic cover missing off rear window wiper arm. Heavy scratches in inside of driver's door frame. Left side wing mirror repeater lens is cracked. Small stone crack in right side of windscreen.
