| Report ID: | 28,124,395 | Version: | 1 |

| Make: | BMW | Model: | 116I |
| Body Style: | Hatchback | Year: | 2012 |

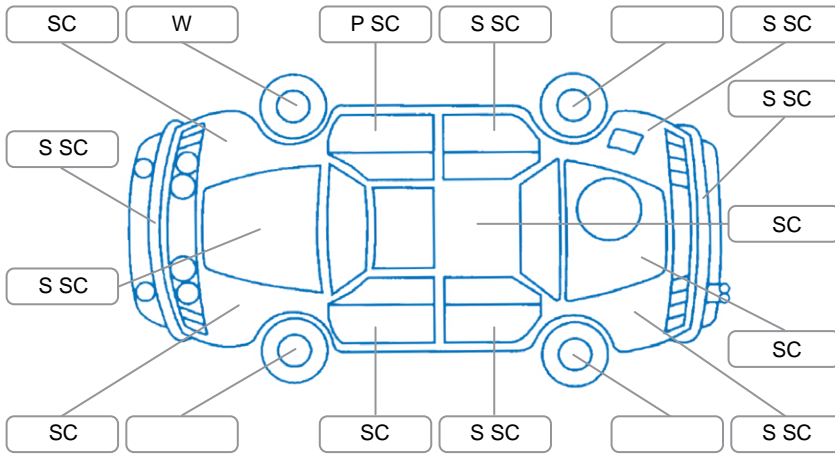
Note: some defects and blemishes may not be displayed in the diagram

Body Inspection Comments

Small cracks on windscreen
 Minor stonechips on windscreen
