Report ID:	28,133,572	Version:	3
Created:	28 Apr 2026

Make:	Toyota	Model:	Hiace
Body Style:	Minibus	Year:	2006
Rego No.:	LAK606	Rego Expiry:	08 Oct 2026
WoF Expiry:	09 Sep 2026	Odometer:	357,177 Kms
Good No.:	28133572	VIN:	7AT0H60FX17549254
Next Service:	322301 kms	Service History:	No

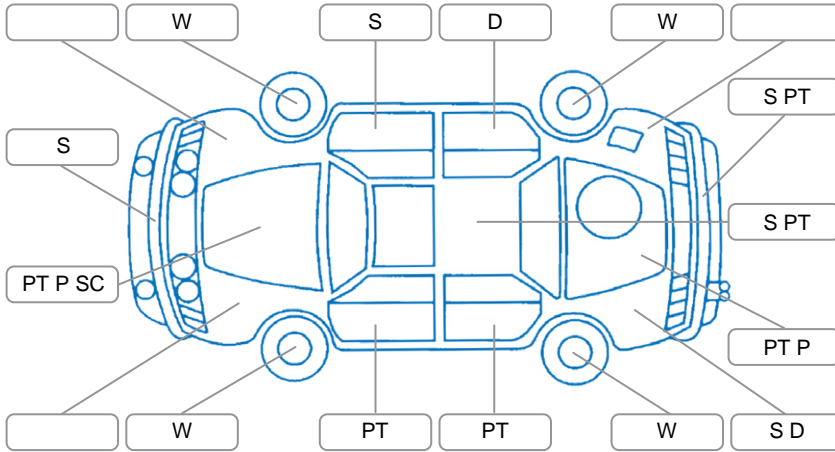
S = Scratch    R = Rust    C = Crack    \* = Decals    W = Significant scuffs  
 D = Dent    PT = Paint defect    P = Pin dent    SC = Stone Chips

Note: some defects and blemishes may not be displayed in the diagram
