Report ID:	28,138,755	Version:	1
Created:	23 Apr 2026

Make:	Nissan	Model:	Tiida
Body Style:	Hatchback	Year:	2005
Rego No.:	LFM306	Rego Expiry:	05 Jun 2026
WoF Expiry:		Odometer:	151,517 Kms
Good No.:	28138755	VIN:	7AT0DH78X18003278
Next Service:	Unknown.	Service History:	No

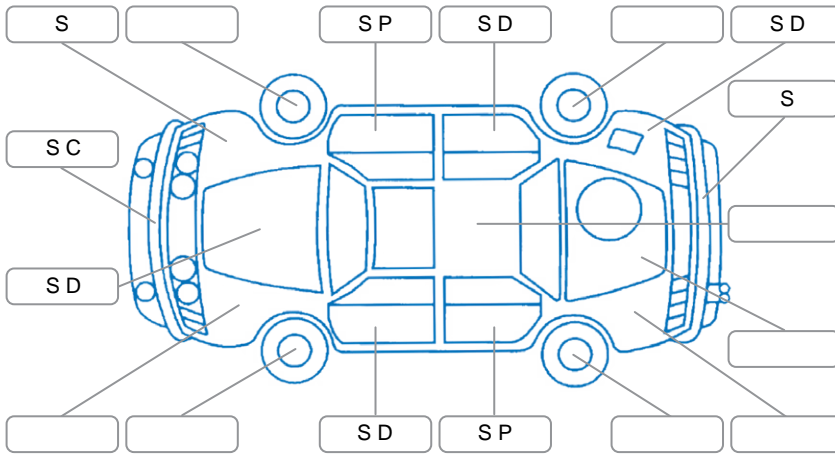
Note: some defects and blemishes may not be displayed in the diagram

- Front bumper clips broken left side, cannot be refitted.
- Hole in front bumper.
- Rear left side of bumper not aligned with fender.
- Left wing mirror paint defect.
