Report ID:	28,139,709	Version:	4
Created:	05 May 2026

Make:	Mitsubishi	Model:	Triton
Body Style:	Utility	Year:	2019
Rego No.:	MKE177	Rego Expiry:	22 Jun 2026
WoF Expiry:	19 Sep 2026	Odometer:	241,556 Kms
Good No.:	28139709	VIN:	MMAJLKK10KH015535
Next Service:	237,700kms	Service History:	No

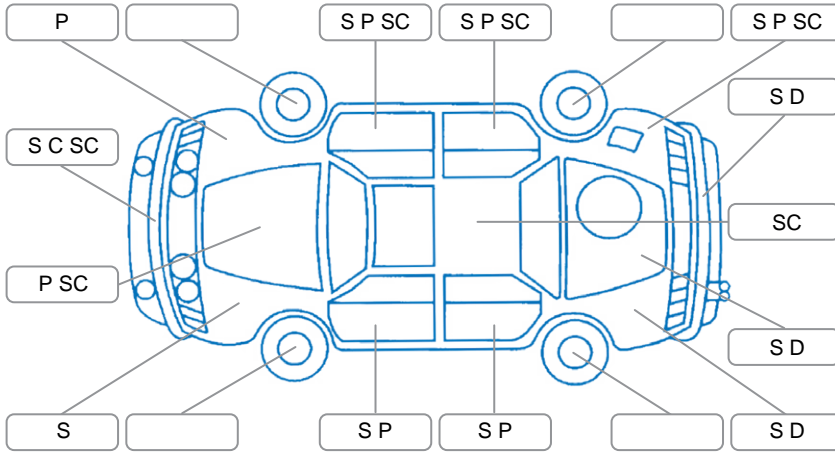
Note: some defects and blemishes may not be displayed in the diagram

Both side running boards are scuffed and paint is flaking. Both sill paint is worn. Canopy back door seal rubber is torn. Left headlight coating is damaged. Rear bumper alignment required. Screw holes inside of right front guard. Tail gate is jammed. Edge of Right tail light is cracked.
