Report ID:	28,146,610	Version:	1
Created:	29 Apr 2026

Make:	Mitsubishi	Model:	L300
Body Style:	Van	Year:	1998
Rego No.:	XA5156	Rego Expiry:	20 May 2026
WoF Expiry:	31 Aug 2026	Odometer:	339,454 Kms
Good No.:	28146610	VIN:	7A1PM5J38WP039021
Next Service:	341,000km	Service History:	No

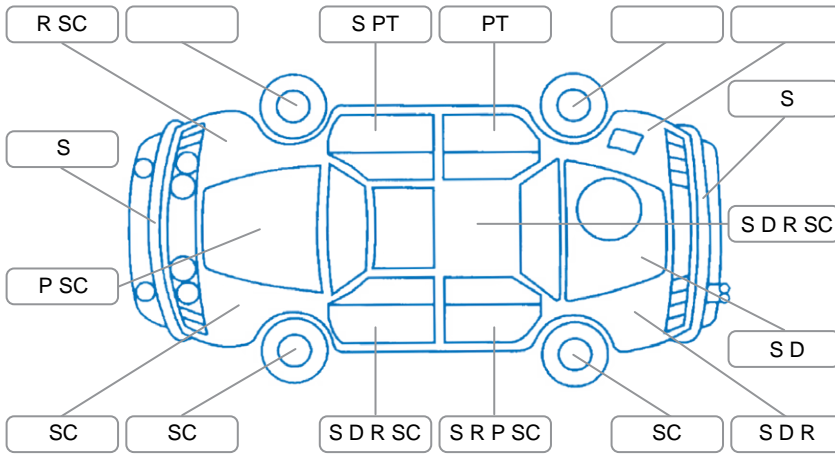
Note: some defects and blemishes may not be displayed in the diagram

Front grille is broken. LF indicator lens is cracked. Rust in left A-pillar. LR taillight is cracked. Right front inner wheel arch is dented. Stone chip in the windscreen. Holes in roof filled in with silicone. Front & rear wheels are mis-matched.
