Report ID:	28,159,780	Version:	1
Created:	06 May 2026

Make:	Volkswagen	Model:	Polo
Body Style:	Hatchback	Year:	2008
Rego No.:	KZQ842	Rego Expiry:	08 Mar 2027
WoF Expiry:	17 Apr 2027	Odometer:	113,128 Kms
Good No.:	28159780	VIN:	WVWZZZ9NZ7Y199505
Next Service:	119,300kms	Service History:	No

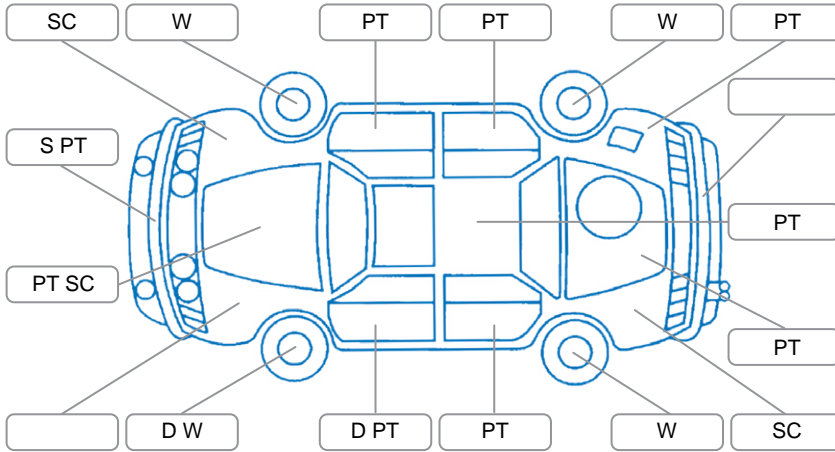
Paint is cracked and flaking on front bumper. Right front wheel is buckled. Clear paint is flaking here and there. Rear wiper arm cap is missing. Right and left tail lights are cracked.
