Make:	Volkswagen	Model:	Golf
Body Style:	Wagon	Year:	2009
Rego No.:	MNZ593	Rego Expiry:	17 May 2026
WoF Expiry:	19 Sep 2026	Odometer:	145,217 Kms
Good No.:	28163241	VIN:	WVWZZZ1KZ8M366442
Next Service:	144000	Service History:	No

### Body Inspection Comments

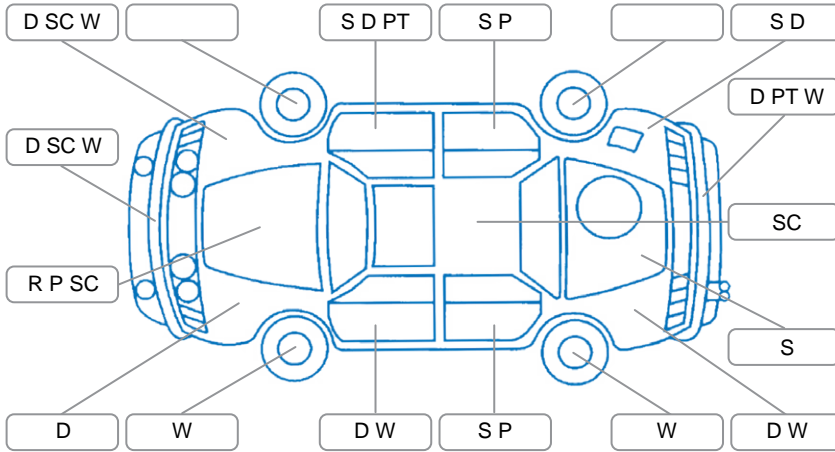
S = Scratch    R = Rust    C = Crack    \* = Decals    W = Significant scuffs  
 D = Dent    PT = Paint defect    P = Pin dent    SC = Stone Chips

Note: some defects and blemishes may not be displayed in the diagram

- Left wing mirror housing and indicator damaged
- Worn front tires
- Front grille damaged
- Left taillight damaged
