Report ID:	28,170,667	Version:	1
Created:	13 May 2026

Make:	Ford	Model:	Transit
Body Style:	Van	Year:	2002
Rego No.:	CAK717	Rego Expiry:	27 Jul 2026
WoF Expiry:	20 Oct 2026	Odometer:	287,034 Kms
Good No.:	28170667	VIN:	WFOLXXGBFL1E21881
Next Service:	296,823kms	Service History:	No

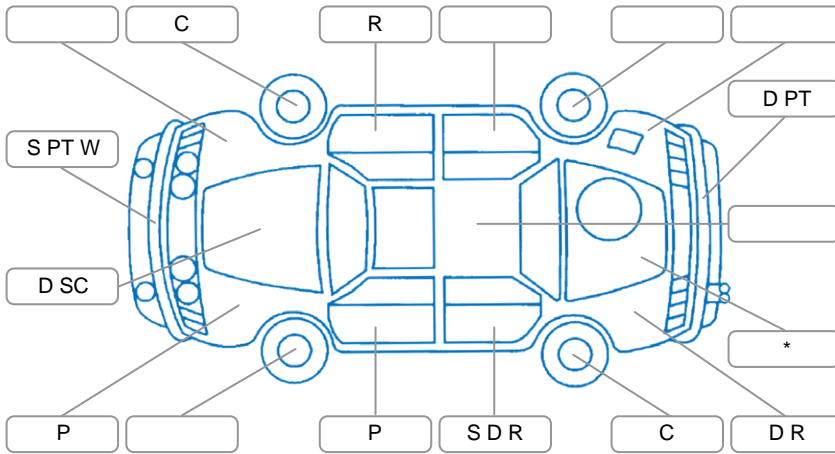
Note: some defects and blemishes may not be displayed in the diagram

12 seater ( LVV for extra 10 seats in rear ). Major crack on side wall of left rear tyre. Right A-pillar is rusty. Decals and glues left around body. Left door mirror glass is delaminated. Dent in right sill under front door. Rear end window glassed cannot be closed properly.
