Report ID:	28,186,640	Version:	1
Created:	19 May 2026

Make:	Ford	Model:	Escape
Body Style:	Wagon	Year:	2006
Rego No.:	JHG410	Rego Expiry:	16 May 2026
WoF Expiry:	23 Sep 2026	Odometer:	150,575 Kms
Good No.:	28186640	VIN:	LFACZYVX62000254
Next Service:	150,400km's	Service History:	No

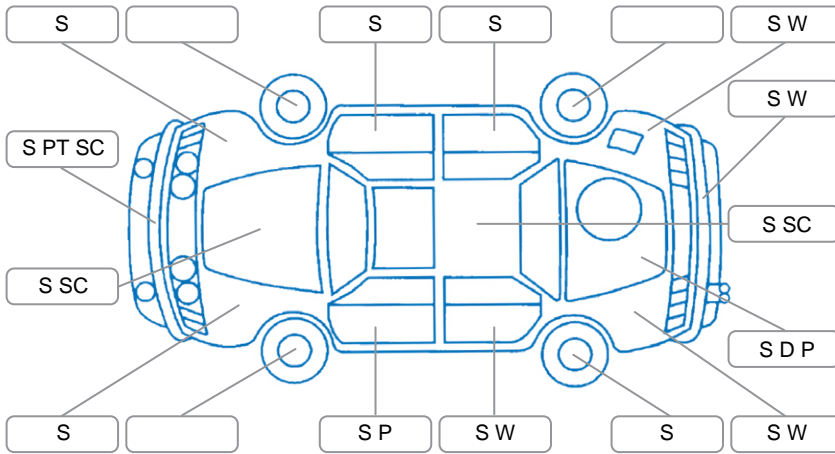
S = Scratch    R = Rust    C = Crack    \* = Decals    W = Significant scuffs  
 D = Dent    PT = Paint defect    P = Pin dent    SC = Stone Chips

Note: some defects and blemishes may not be displayed in the diagram

Reversing camera is not showing a clear picture. Front spotlights are missing out of front bumper. Right rear taillight lens is cracked & broken. Dents in left side running board, has spots of black paint along running board.
