Report ID:	28,209,000	Version:	2
Created:	10 Jun 2026

Make:	Volkswagen	Model:	Crafter
Body Style:	Van	Year:	2021
Rego No.:	NFQ409	Rego Expiry:	13 Jan 2027
WoF Expiry:	03 Feb 2027	Odometer:	114,868 Kms
Good No.:	28209000	VIN:	WV1ZZSYZM9010729
Next Service:	120,000 kms	Service History:	Yes

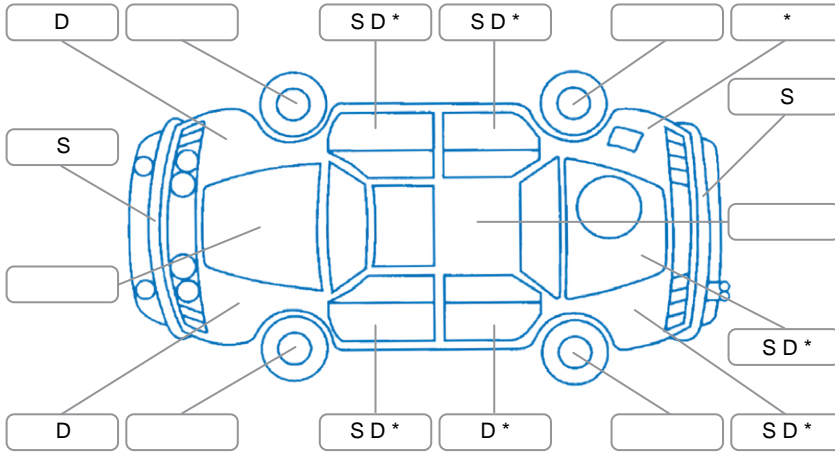
Note: some defects and blemishes may not be displayed in the diagram

Rear tail badge missing, L front outer cv boot split, oil service due, front bumper left moulding needs refit, Left Front Tyre outer edge wear, Left Rear Tyre outer edge wear, right tail light scuffs, B pillar dents, right side sill dent
