| Report ID: | 28,222,697 | Version: | 2 |

| Make: | Nissan | Model: | Pulsar |
| Body Style: | Hatchback | Year: | 2015 |

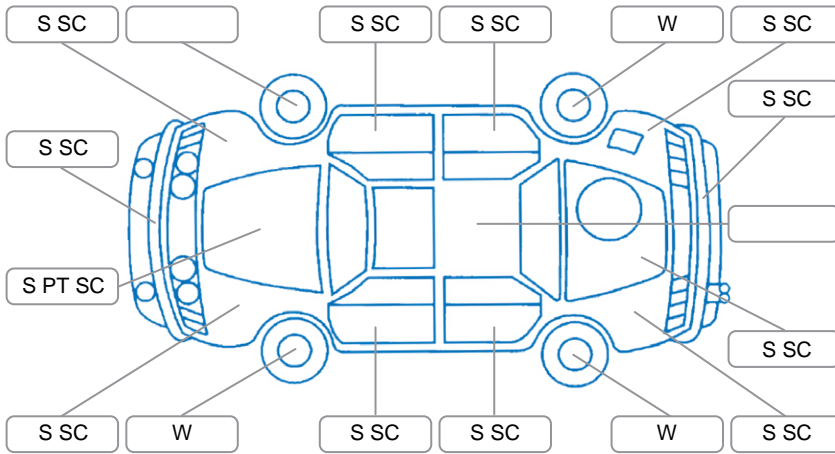
Key
 S = Scratch R = Rust C = Crack * = Decals W = Significant scuffs
 D = Dent PT = Paint defect P = Pin dent SC = Stone Chips

Note: some defects and blemishes may not be displayed in the diagram
