Report ID:	28,224,084	Version:	1
Created:	03 Jun 2026

Make:	Mazda	Model:	Axela
Body Style:	Hatchback	Year:	2005
Rego No.:	HSW759	Rego Expiry:	15 Jul 2026
WoF Expiry:	25 Jul 2026	Odometer:	208,699 Kms
Good No.:	28224084	VIN:	7AT0C13JX14213695
Next Service:	203,591 Kms	Service History:	No

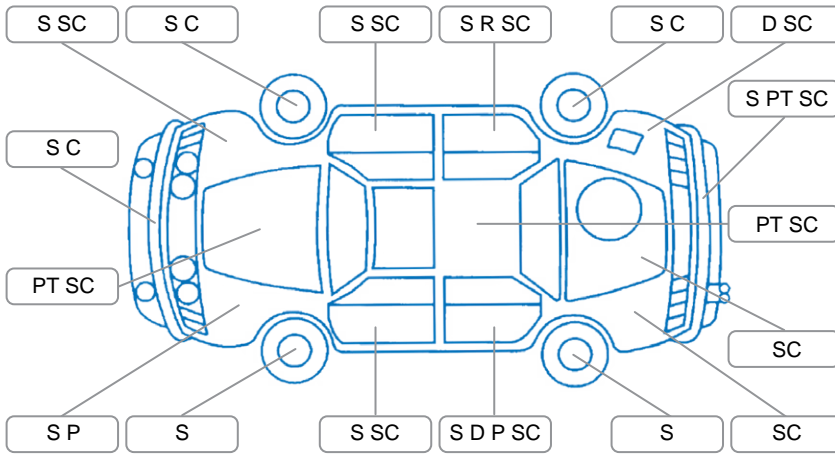
Note: some defects and blemishes may not be displayed in the diagram

Hairline cracks in both headlights. Rust in RR door frame.
 Front bumper lower LH moulding loose. Surface rust in spare wheel well.
 RF door seal loose. 2 roof gutter moulding caps missing.
 RF door jam/B pillar dented and scratched. Aerial stalk damaged.
