Report ID:	28,231,096	Version:	1
Created:	12 Jun 2026

Make:	Ford	Model:	Mondeo
Body Style:	Wagon	Year:	1998
Rego No.:	ADC753	Rego Expiry:	19 Sep 2026
WoF Expiry:	13 Jul 2026	Odometer:	295,497 Kms
Good No.:	28231096	VIN:	WFONXXGBBNVE83794
Next Service:	297,933km's	Service History:	No

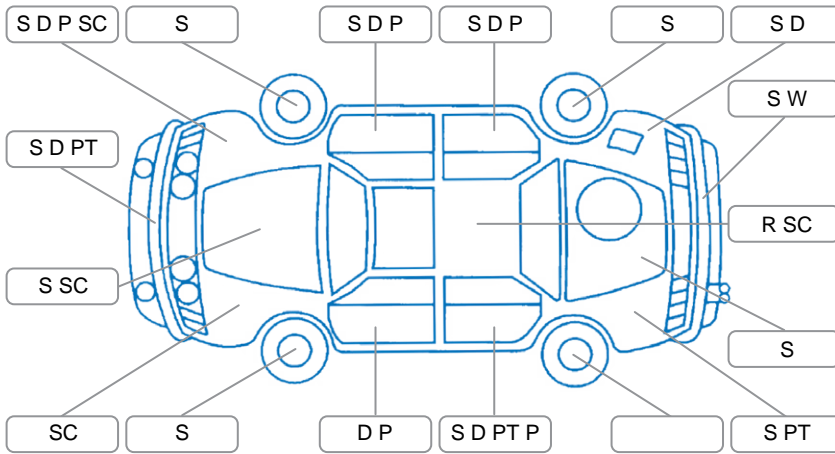
Note: some defects and blemishes may not be displayed in the diagram

Paint clear coat peeling off front bumper. Right corner of front bumper is not fitting properly. Hole in right side of front bumper. Both rear tyres & right front tyre will need replacing soon, tread depth is very low. Dent & scratches in left front sill.
