| Report ID: | 28,232,671 | Version: | 1 |

| Make: | Nissan | Model: | Regulus |
| Body Style: | Wagon | Year: | 1997 |

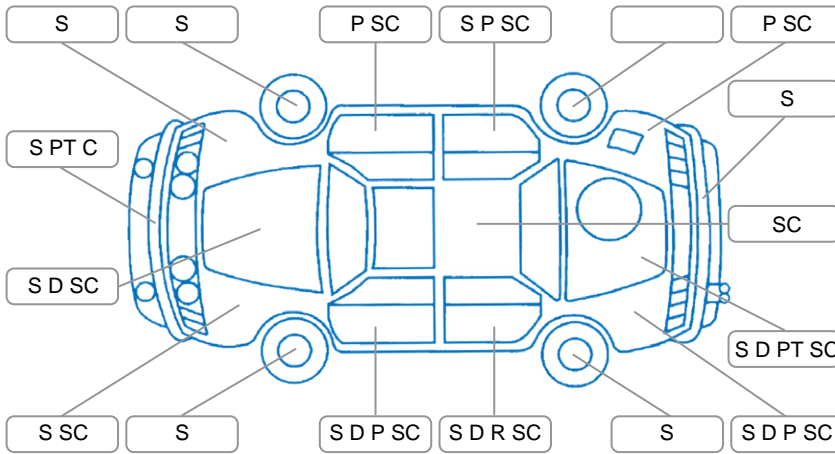
Key
 S = Scratch R = Rust C = Crack * = Decals W = Significant scuffs
 D = Dent PT = Paint defect P = Pin dent SC = Stone Chips

Note: some defects and blemishes may not be displayed in the diagram

Both running boards scuffed. Wiper arms need repainted.
 LF door window monsoon damaged.
 LH side mirror scuffed.
 Front bumper zip tied on LH side.
