Report ID:	28,236,866	Version:	1
Created:	11 Jun 2026

Make:	Mitsubishi	Model:	Delica
Body Style:	SUV	Year:	2003
Rego No.:	JFL974	Rego Expiry:	11 Jul 2026
WoF Expiry:	11 Sep 2026	Odometer:	243,271 Kms
Good No.:	28236866	VIN:	7AT0CJ0PX11900446
Next Service:	249,000km's	Service History:	No

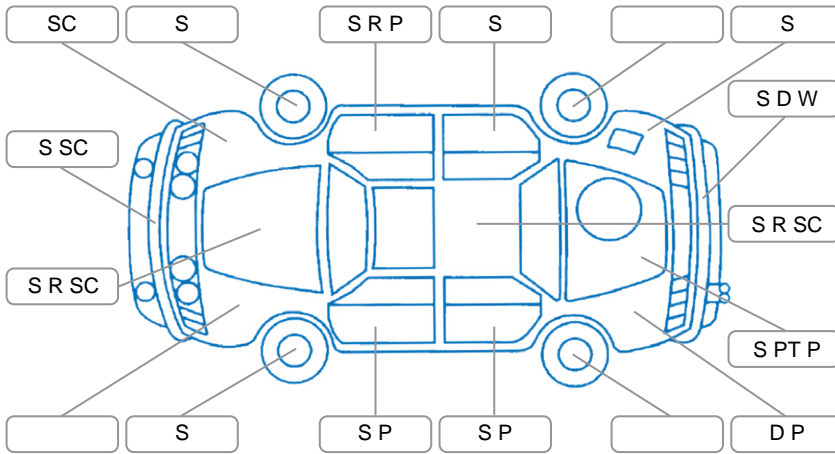
Note: some defects and blemishes may not be displayed in the diagram

Surface rust in engine bay, around top radiator support panel. Crack in left front indicator lens.
