Report ID:	28,237,244	Version:	1
Created:	10 Jun 2026

Make:	Nissan	Model:	Tiida
Body Style:	Hatchback	Year:	2005
Rego No.:	LRW104	Rego Expiry:	08 Apr 2027
WoF Expiry:	07 Mar 2027	Odometer:	115,104 Kms
Good No.:	28237244	VIN:	7AT0DH78X18039469
Next Service:	121,000	Service History:	No

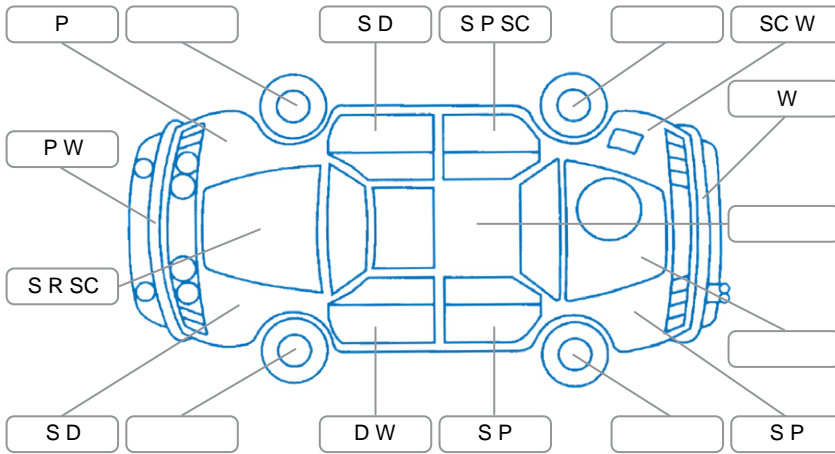
Note: some defects and blemishes may not be displayed in the diagram

- Right wing mirror housing damage
- Rear bumper misaligned
- Left wing mirror housing scuff
- Left side skirt scuff
