Report ID:	28,250,684	Version:	2
Created:	17 Jun 2026

Make:	Subaru	Model:	Legacy
Body Style:	Wagon	Year:	1996
Rego No.:	UC5668	Rego Expiry:	01 Jul 2026
WoF Expiry:	20 Oct 2026	Odometer:	238,866 Kms
Good No.:	28250684	VIN:	JF1BG7KJ4TG021817
Next Service:	244,100 Kms	Service History:	Yes

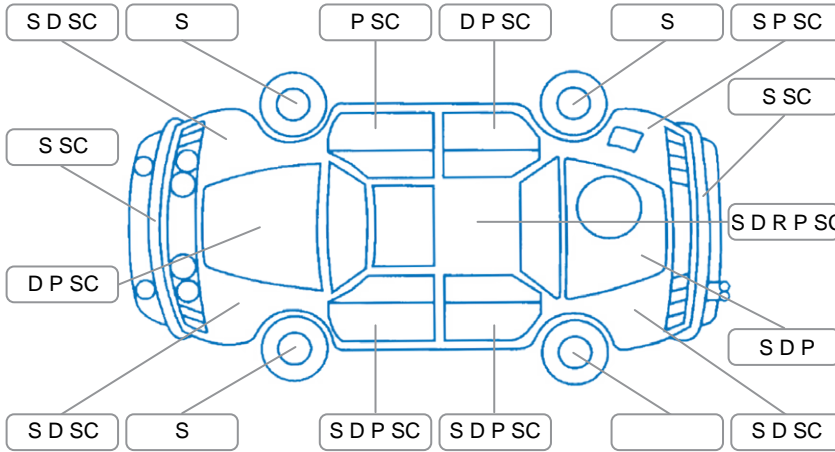
RH side window monsoon missing.      RH side mirror base taped up.  
 Hail damage on roof and bonnet.  
 Spider rust and rust bubbling on roof along on edge of windscreen.  
 Rear tyres getting low on tread.
