| Report ID: | 28,253,022 | Version: | 1 |

| Make: | Great Wall | Model: | V-Series |
| Body Style: | Utility | Year: | 2015 |

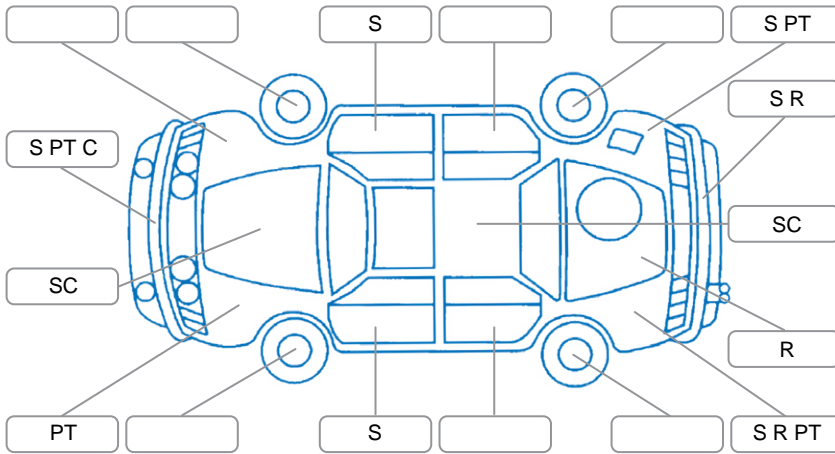
S = Scratch R = Rust C = Crack * = Decals W = Significant scuffs
 D = Dent PT = Paint defect P = Pin dent SC = Stone Chips

Note: some defects and blemishes may not be displayed in the diagram
