Report ID:	28,258,721	Version:	1
Created:	03 Jul 2026

Make:	Nissan	Model:	Fuga
Body Style:	Sedan	Year:	2007
Rego No.:	MUP91	Rego Expiry:	10 Jul 2026
WoF Expiry:	10 Jul 2027	Odometer:	155,723 Kms
Good No.:	28258721	VIN:	7AT0DH8GX19155480
Next Service:	165,721kms	Service History:	No

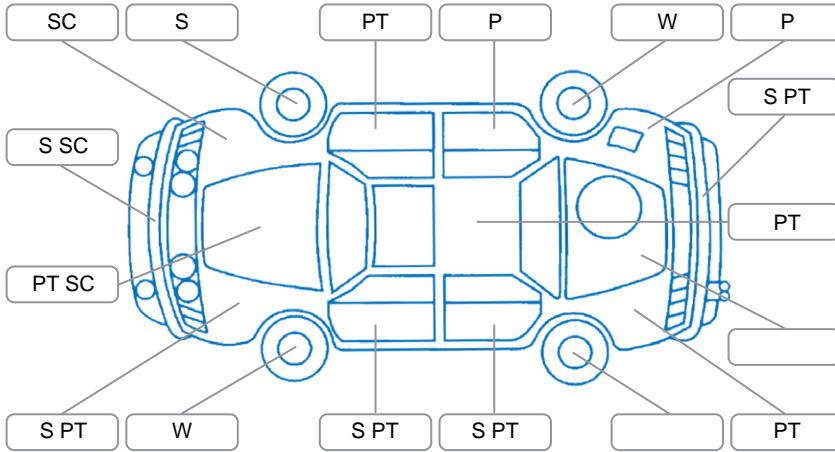
Note: some defects and blemishes may not be displayed in the diagram

Both side body kits are cracked and not fitted correctly. Right rear door chrome moulding is coming off. Paint is fading on roof bonnet doors. Battery cover trim is missing. Right front door seal rubber is worn, torn.
